DOT HS 806 842

Final Report

September 1984

Side-Impact Aggressiveness Attributes MDB-To-Car Side Impact Test of a 19° Crabbed Moving Deformable Barrier to a 1981 Volkswagen Rabbit at 46.4 Mph

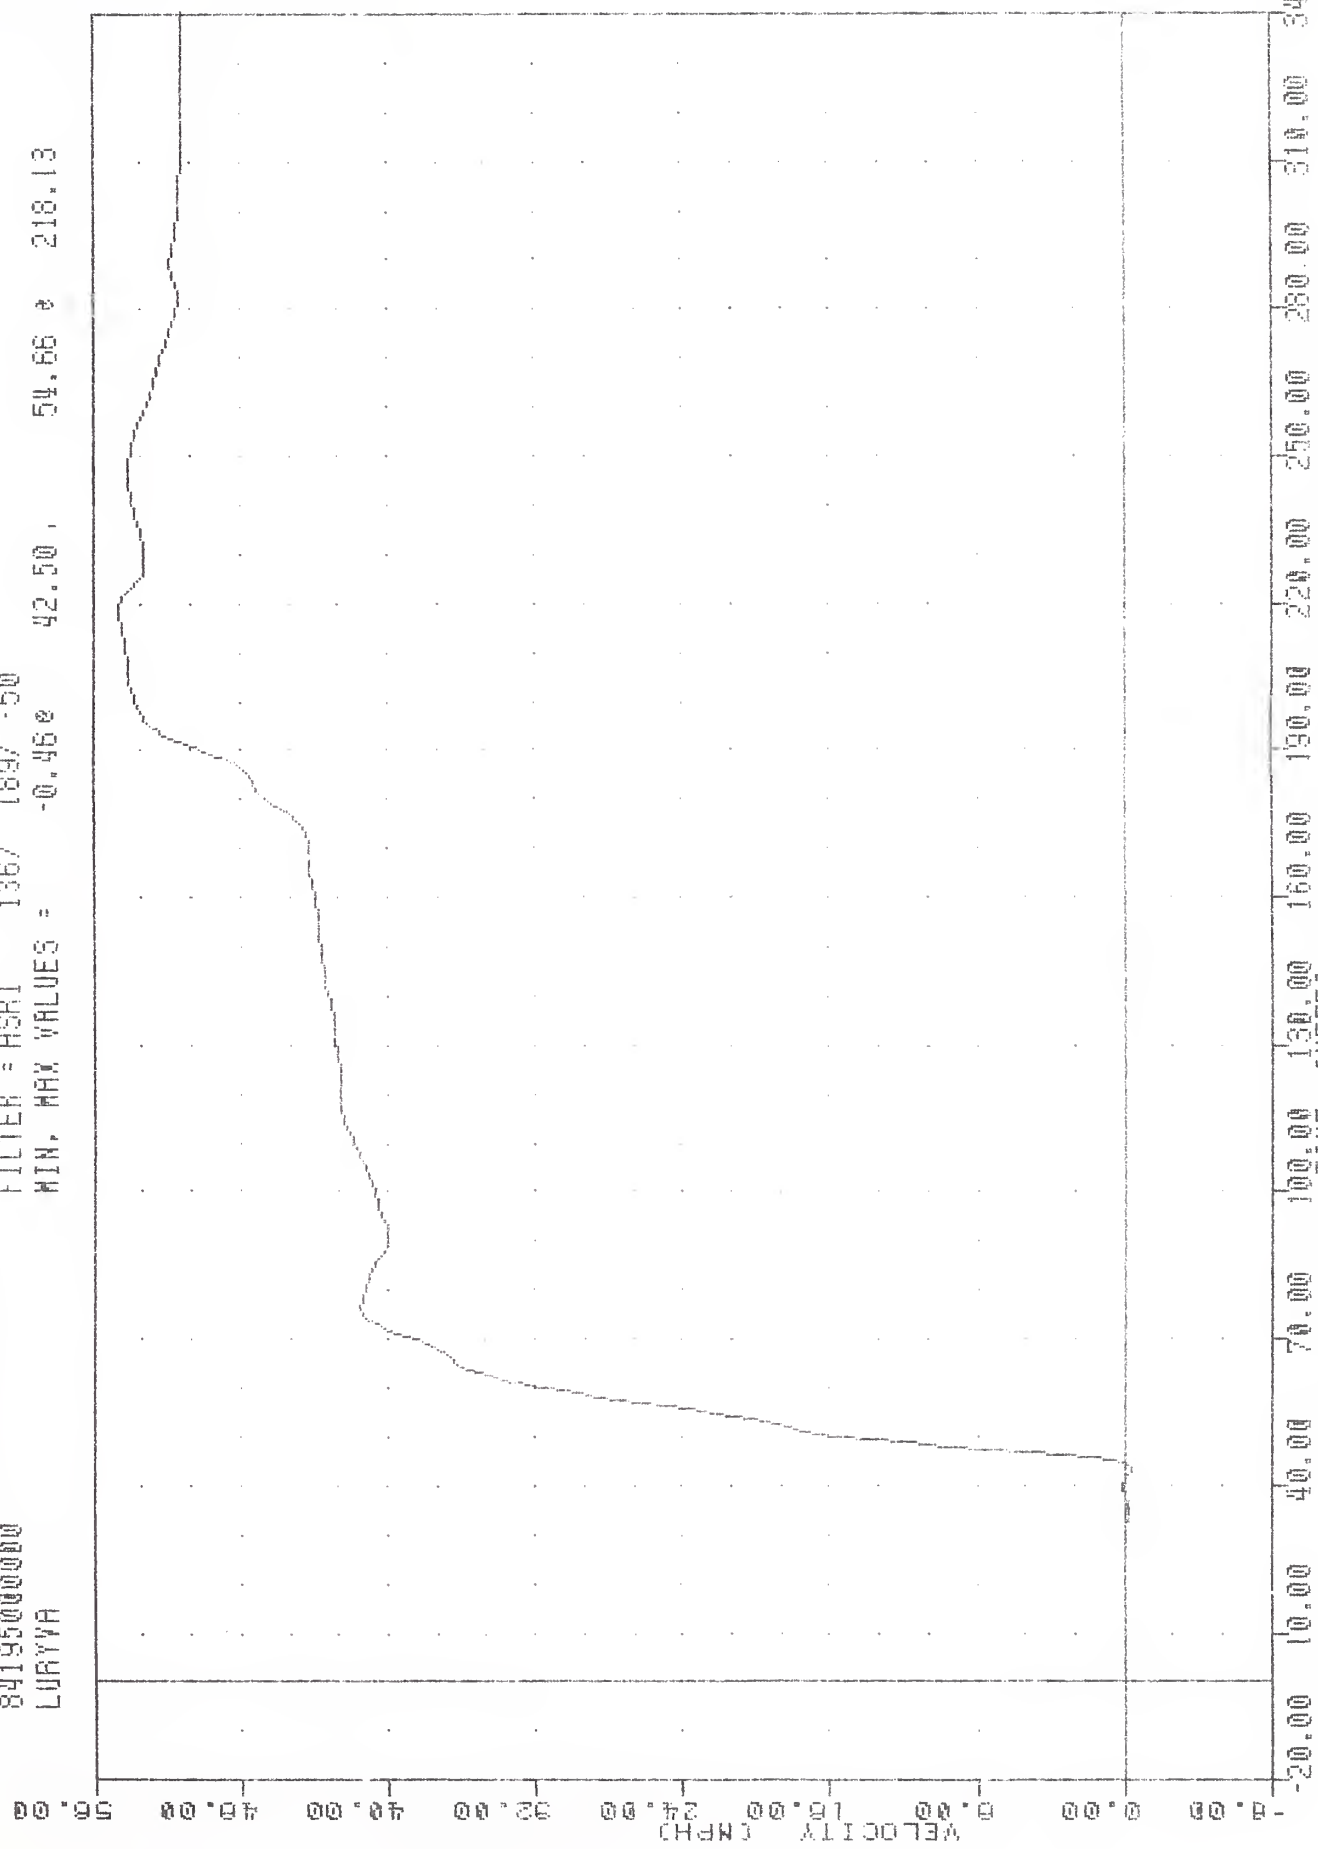
MOVING DEFORMABLE BARRIER INTO VOLKSWAGEN RABBIT
 DELTA V USING LURYGA

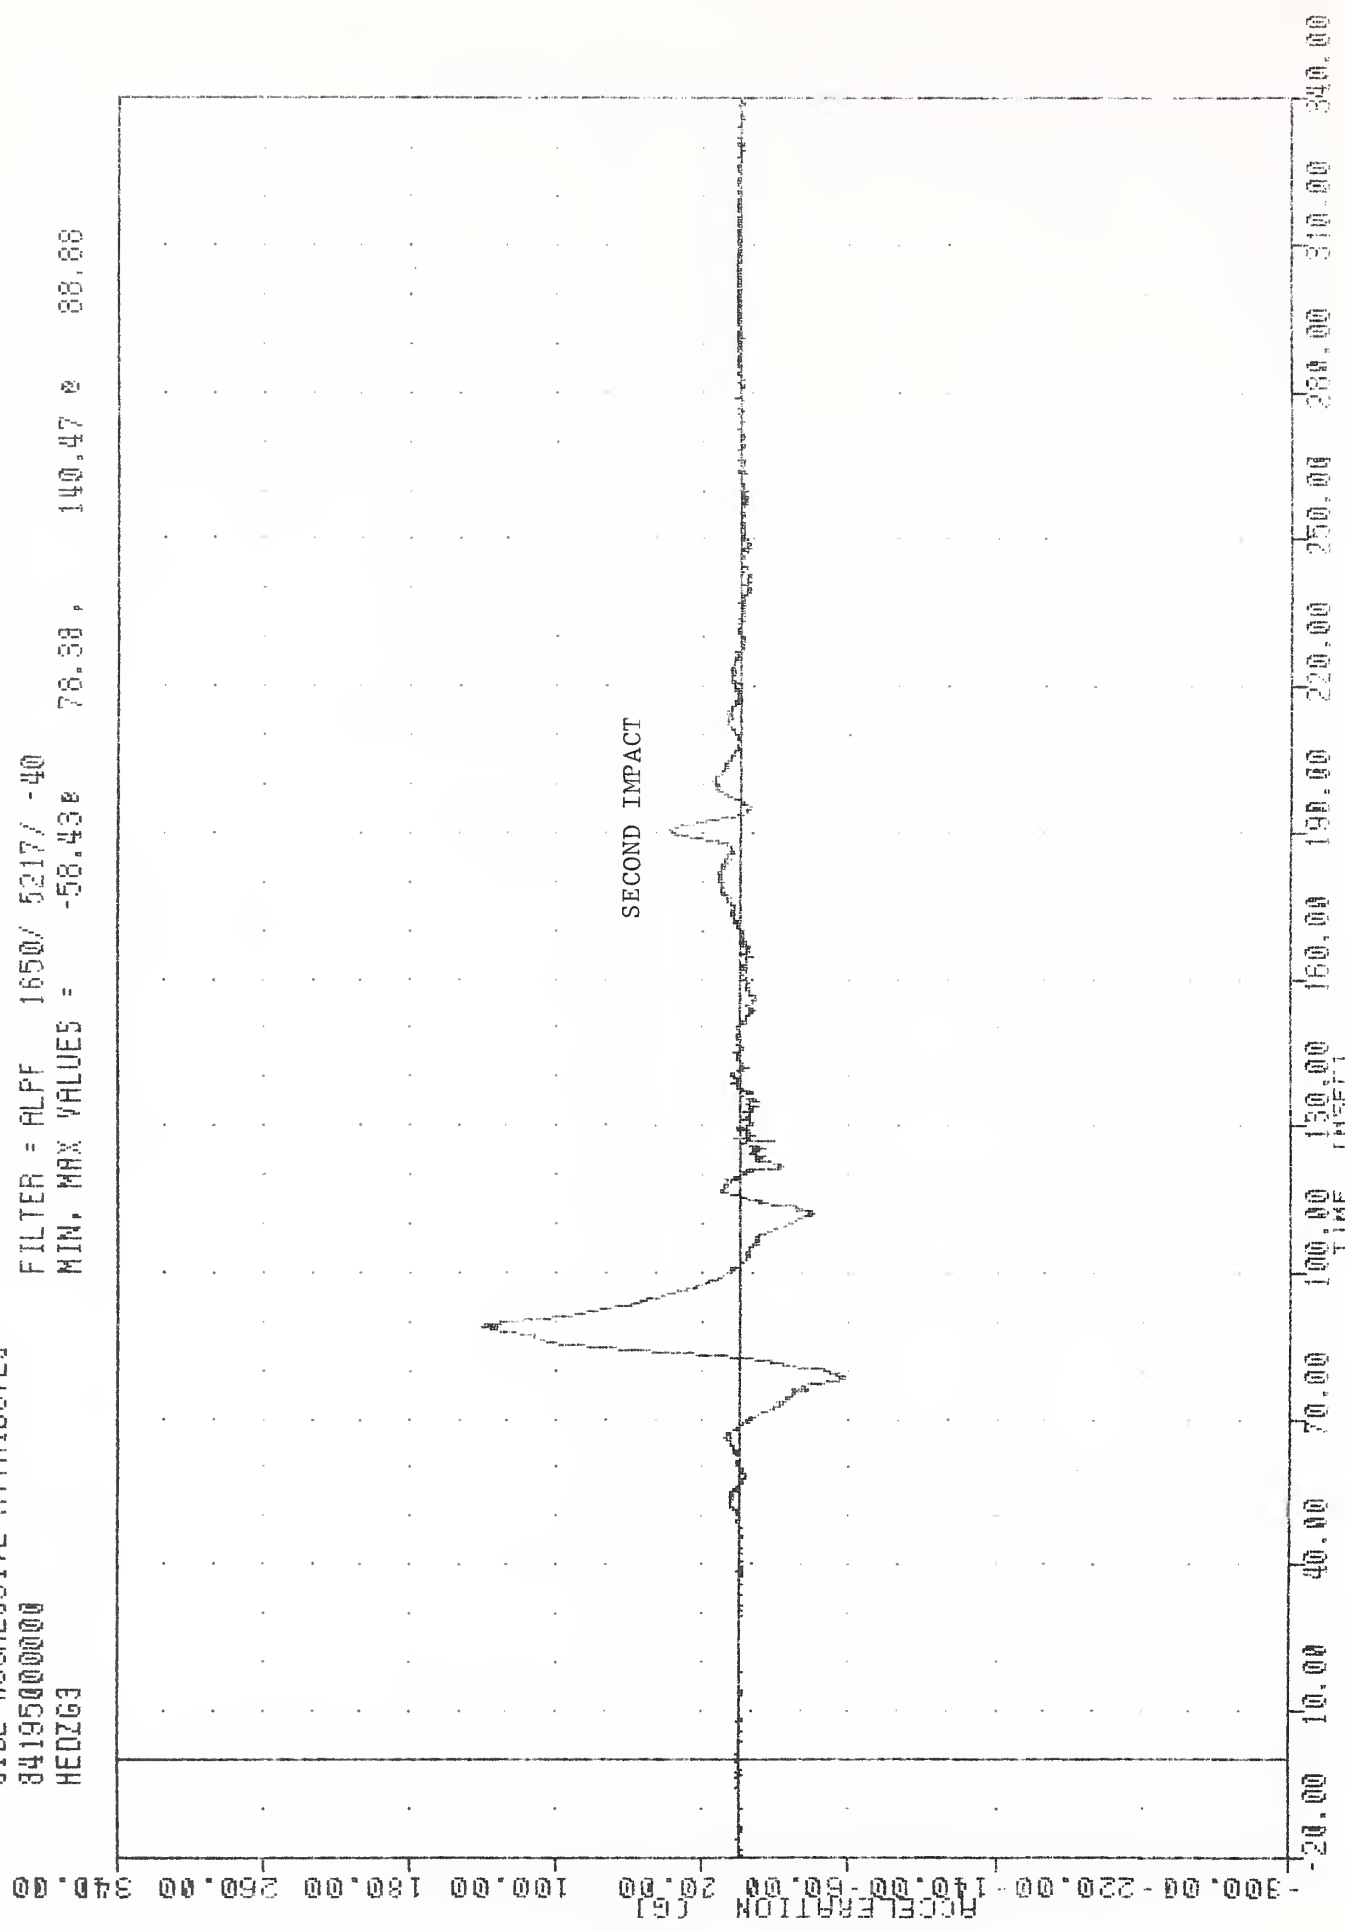
MOVING DEFORMABLE BARRIER INTO VOLKSWAGEN RABBIT
 PASSENGER HEAD ACCELERATION Z AXIS

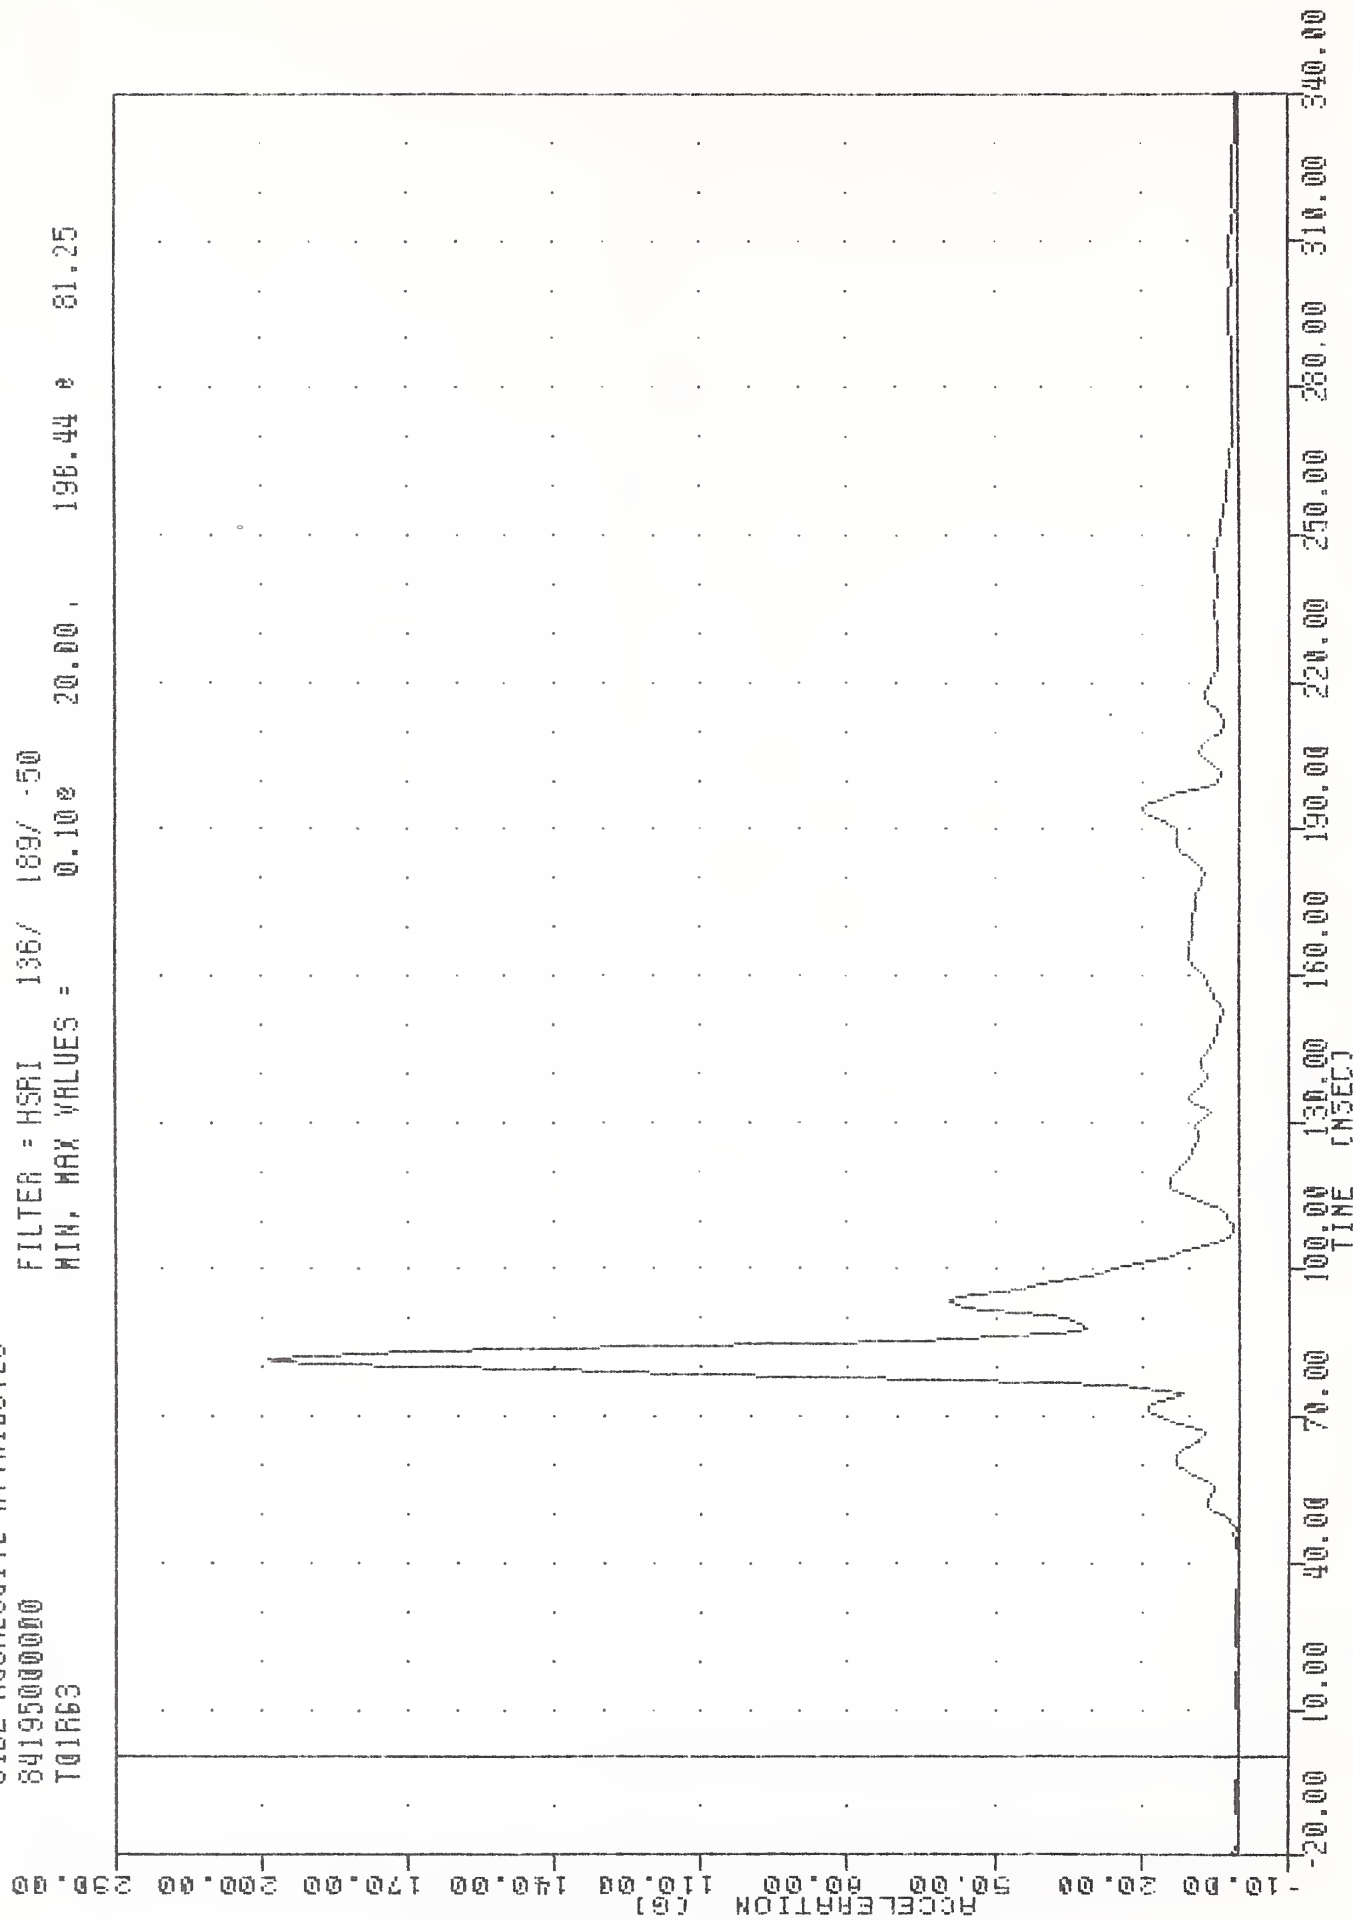
MOVING DEFORMABLE BARRIER INTO VOLKSWAGEN RABBIT
 PASSENGER UPPER SPINE RESULTANT

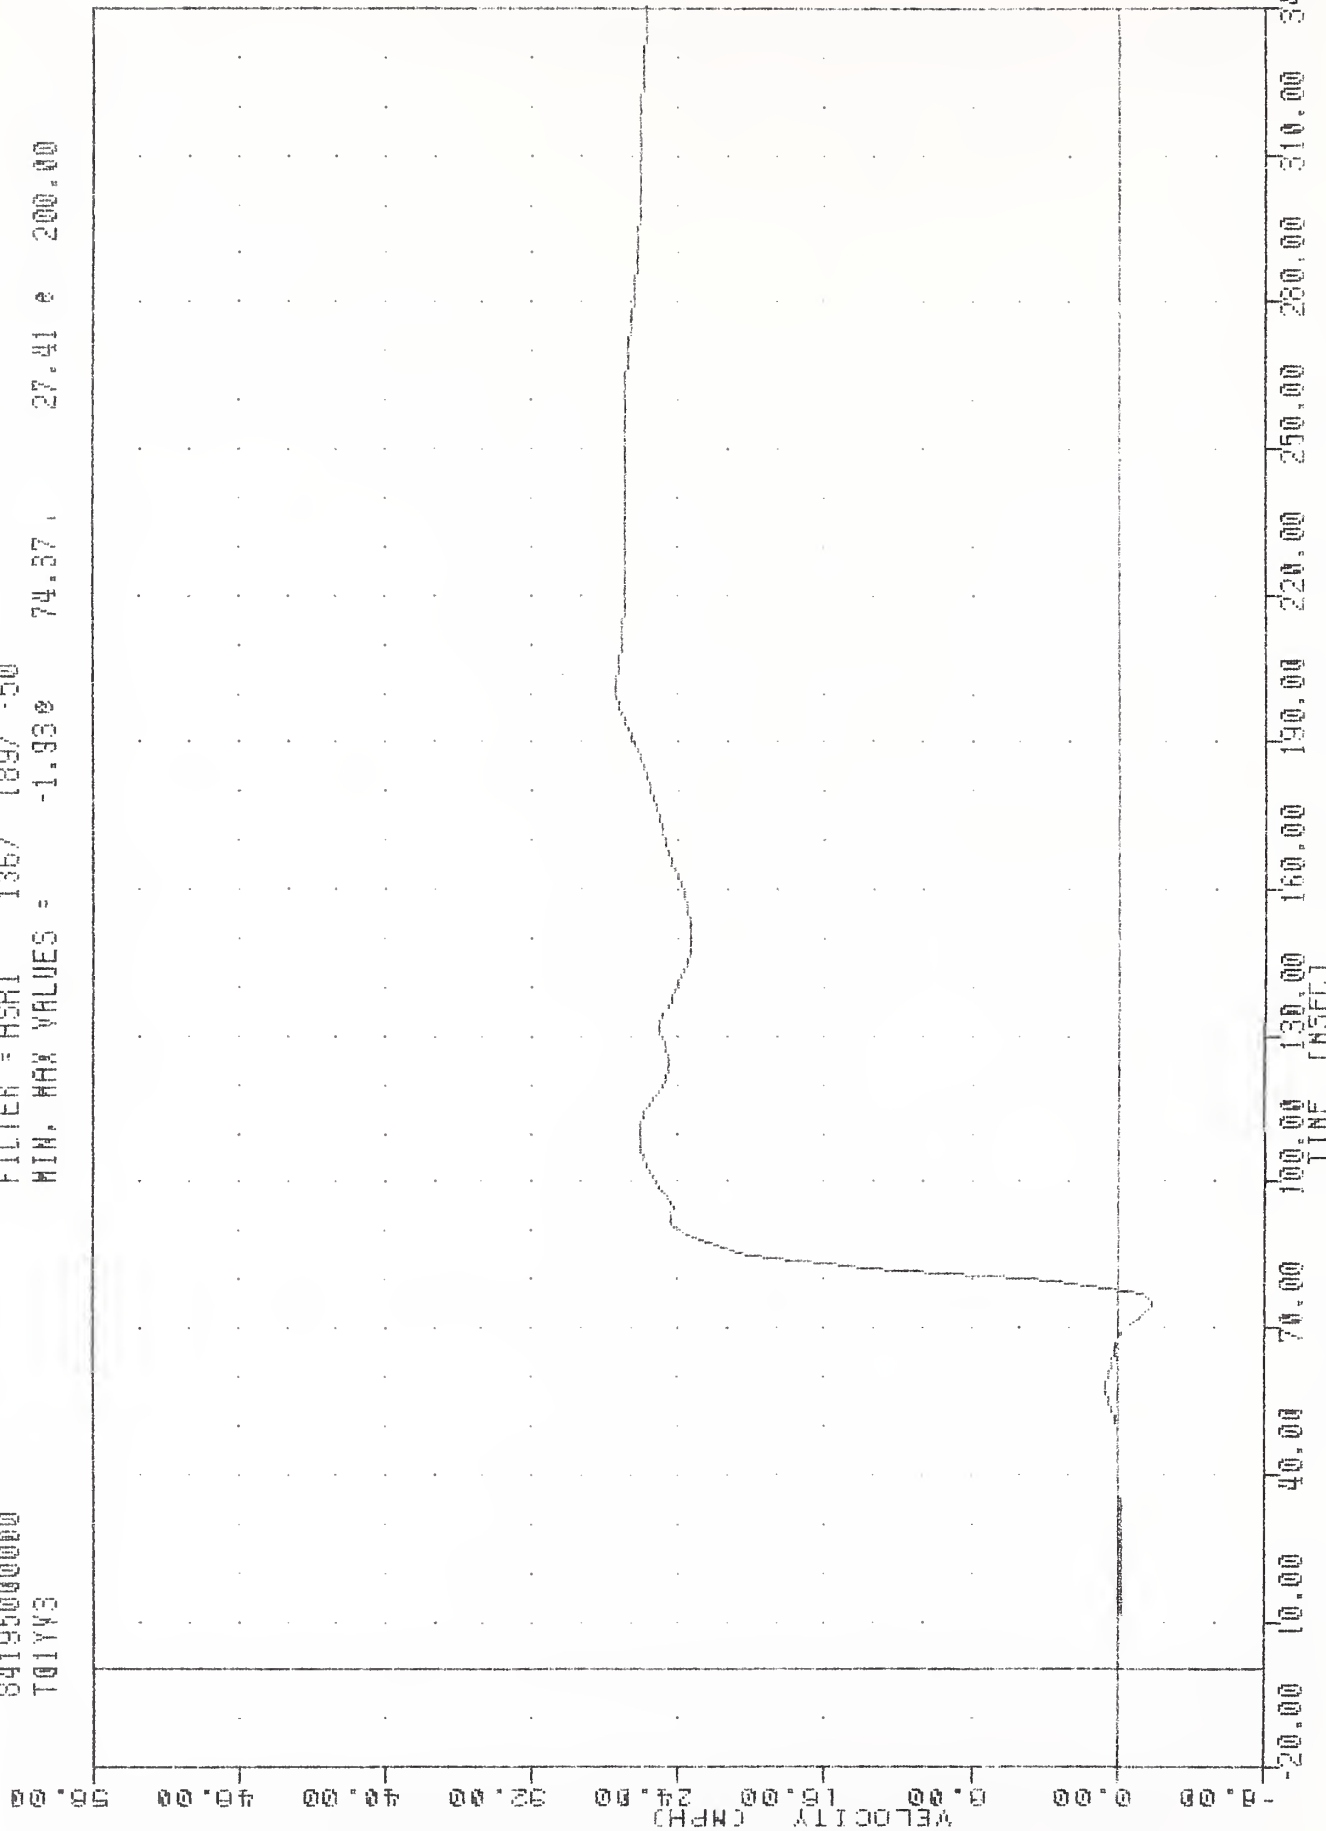
MOVING DEFORMABLE BARRIER INTO VOLKSWAGEN RABBIT
 DELTA V USING T01YV3

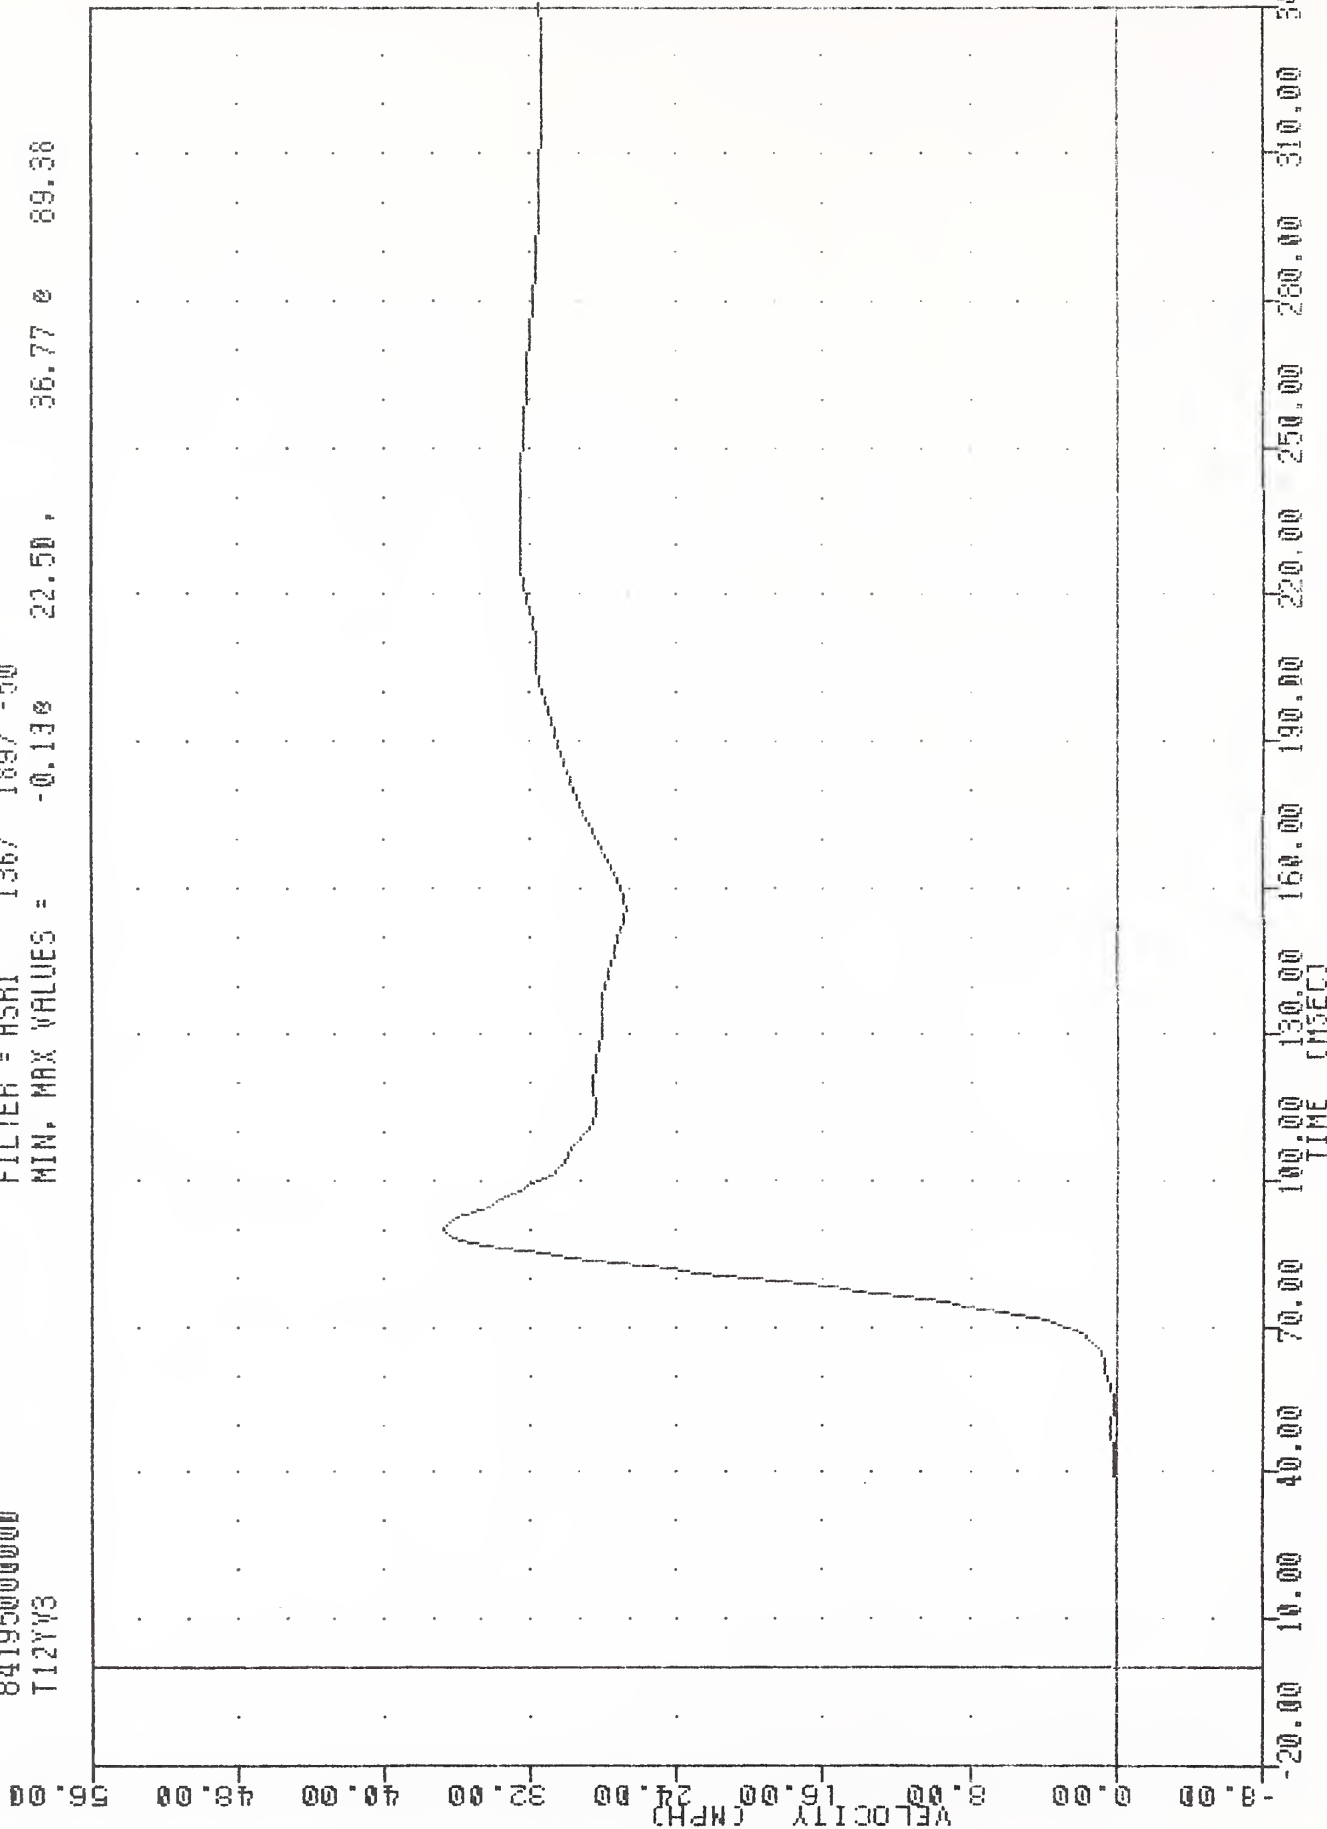
MOVING DEFORMABLE BARRIER INTO VOLKSWAGEN RABBIT
DELTA V USING T12Y63

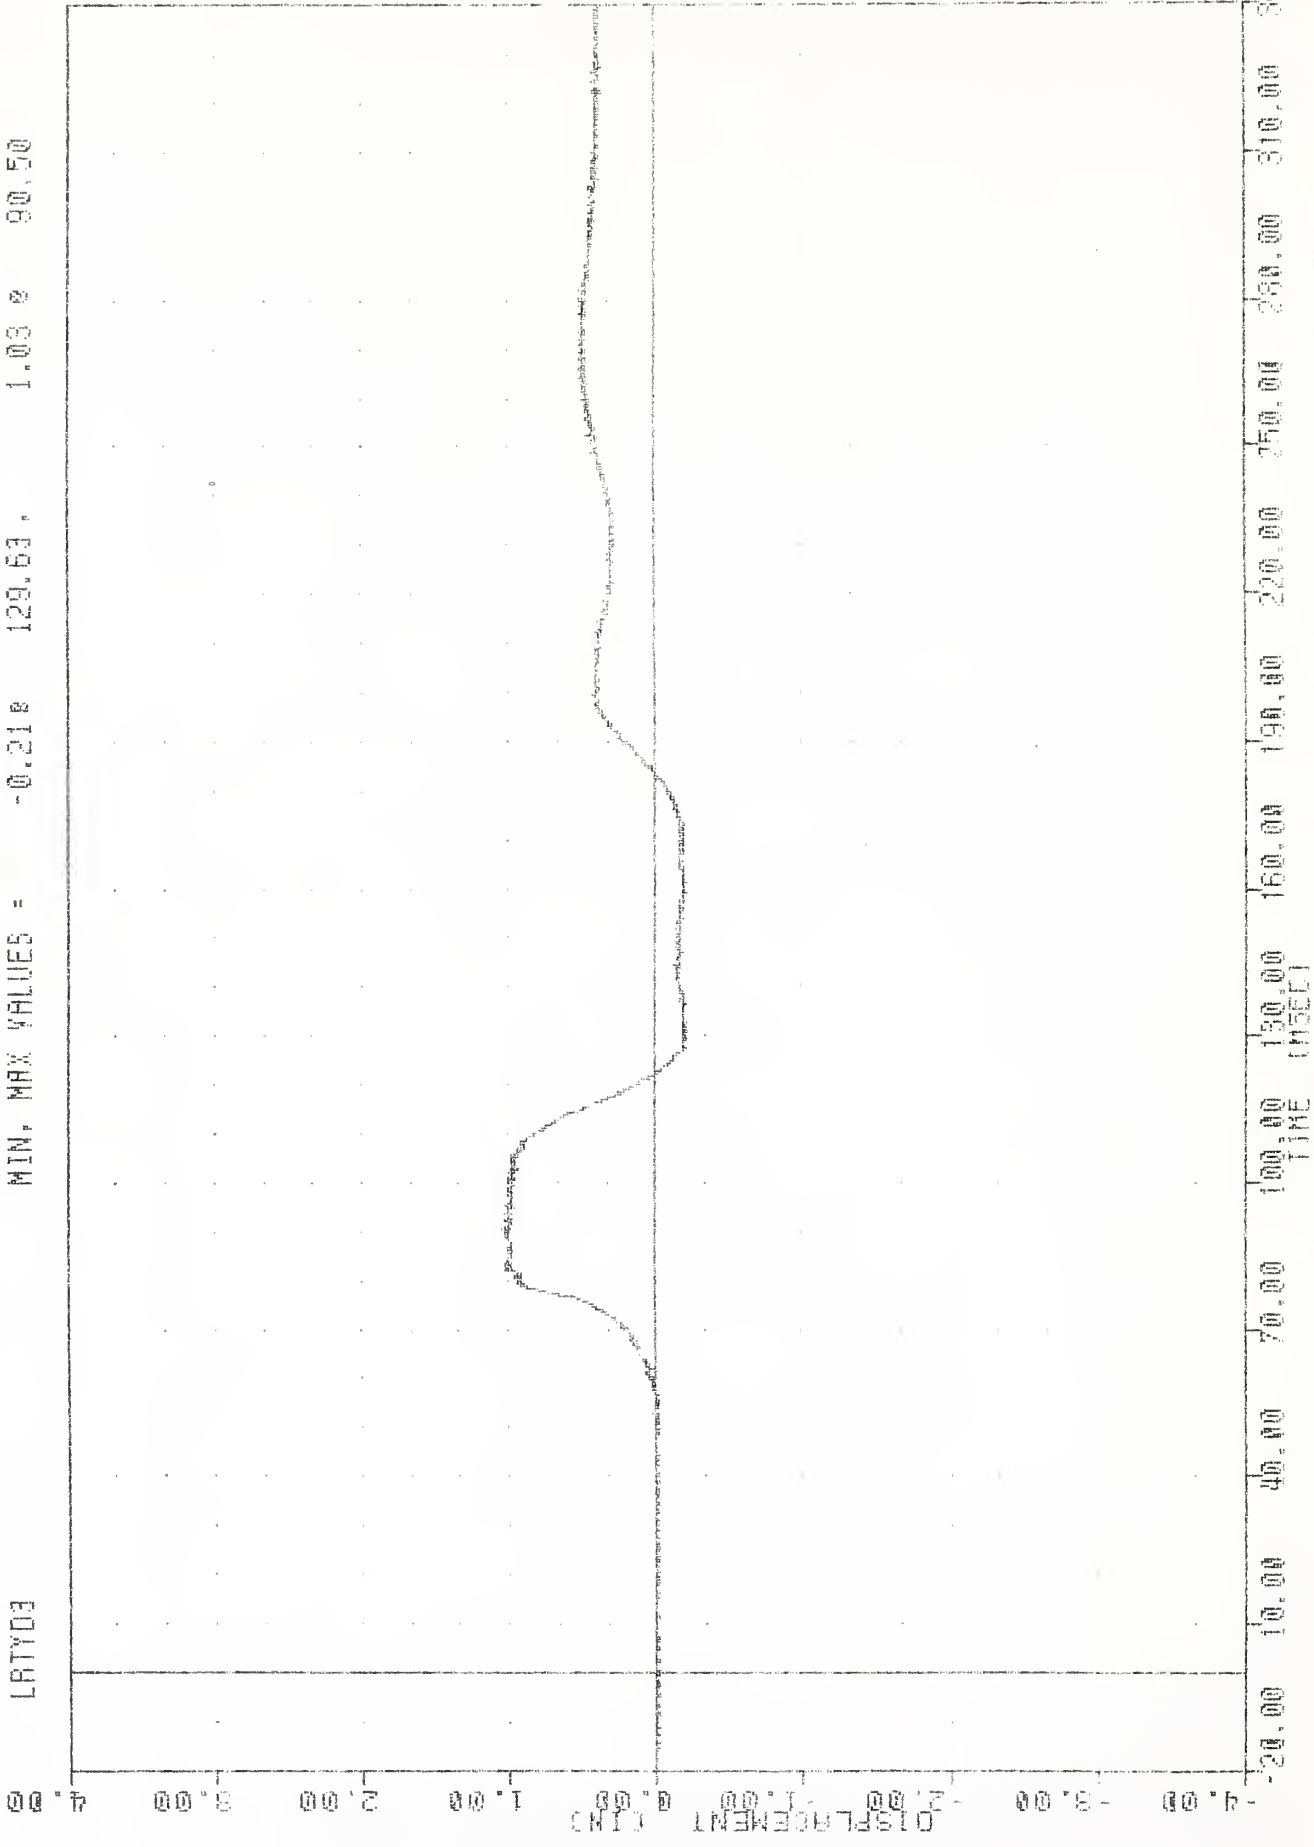
MOVING DEFORMABLE BARRIER INTO VOLSWAAGEN RABBIT
 PASSENGER LEFT RIB TO SPINE DISPLACEMENT INCHES

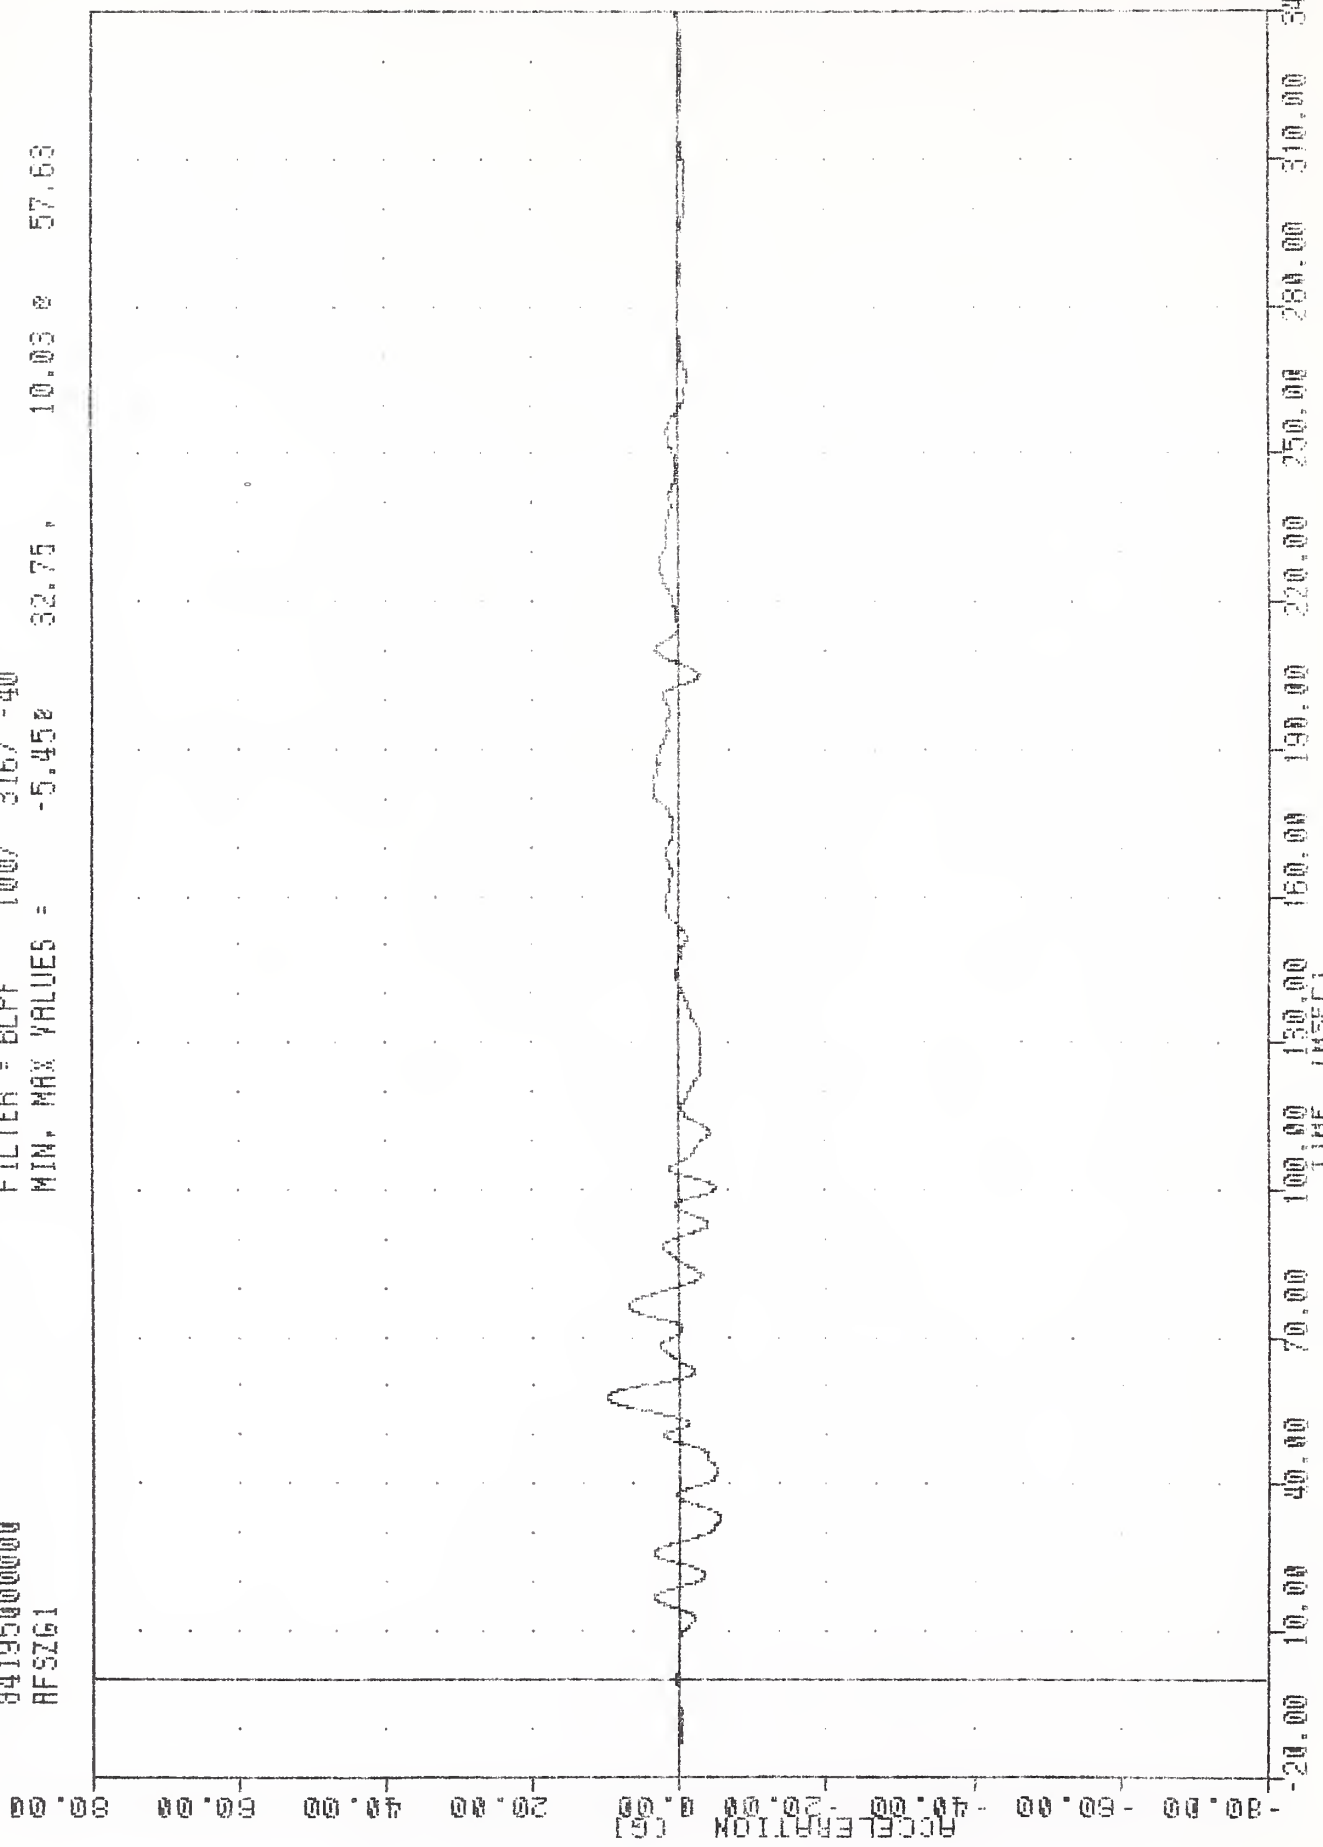
MOVING DEFORMABLE BARRIER INTO VOLKSWAGEN RABBIT
 VEHICLE RIGHT FRONT STILL ACCELERATION Z AXIS

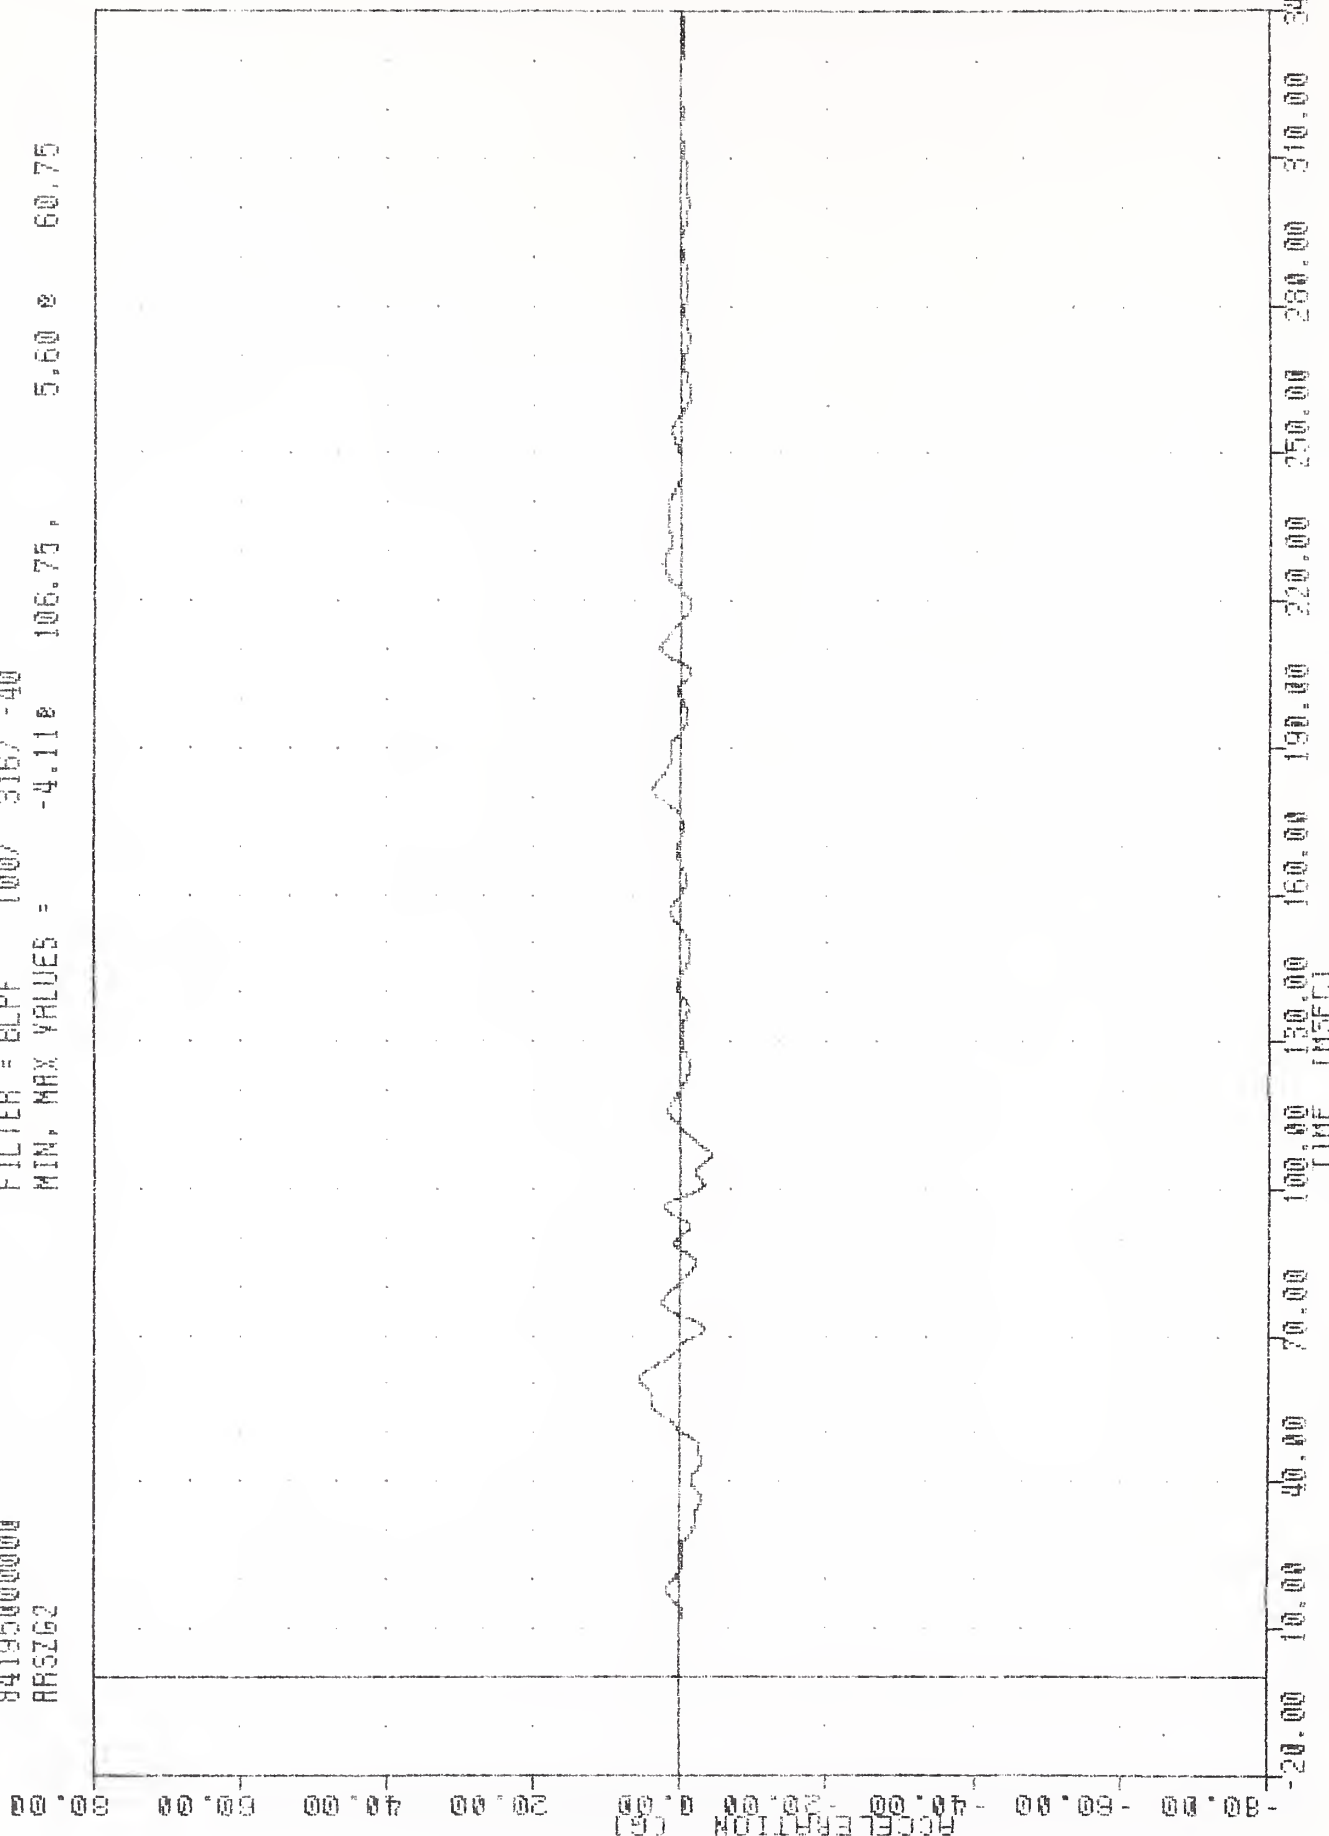
MOVING DEFORMABLE BARRIER INTO VOLKSWAGEN RABBIT
VEHICLE RIGHT REAR SILL ACCELERATION Z AXIS

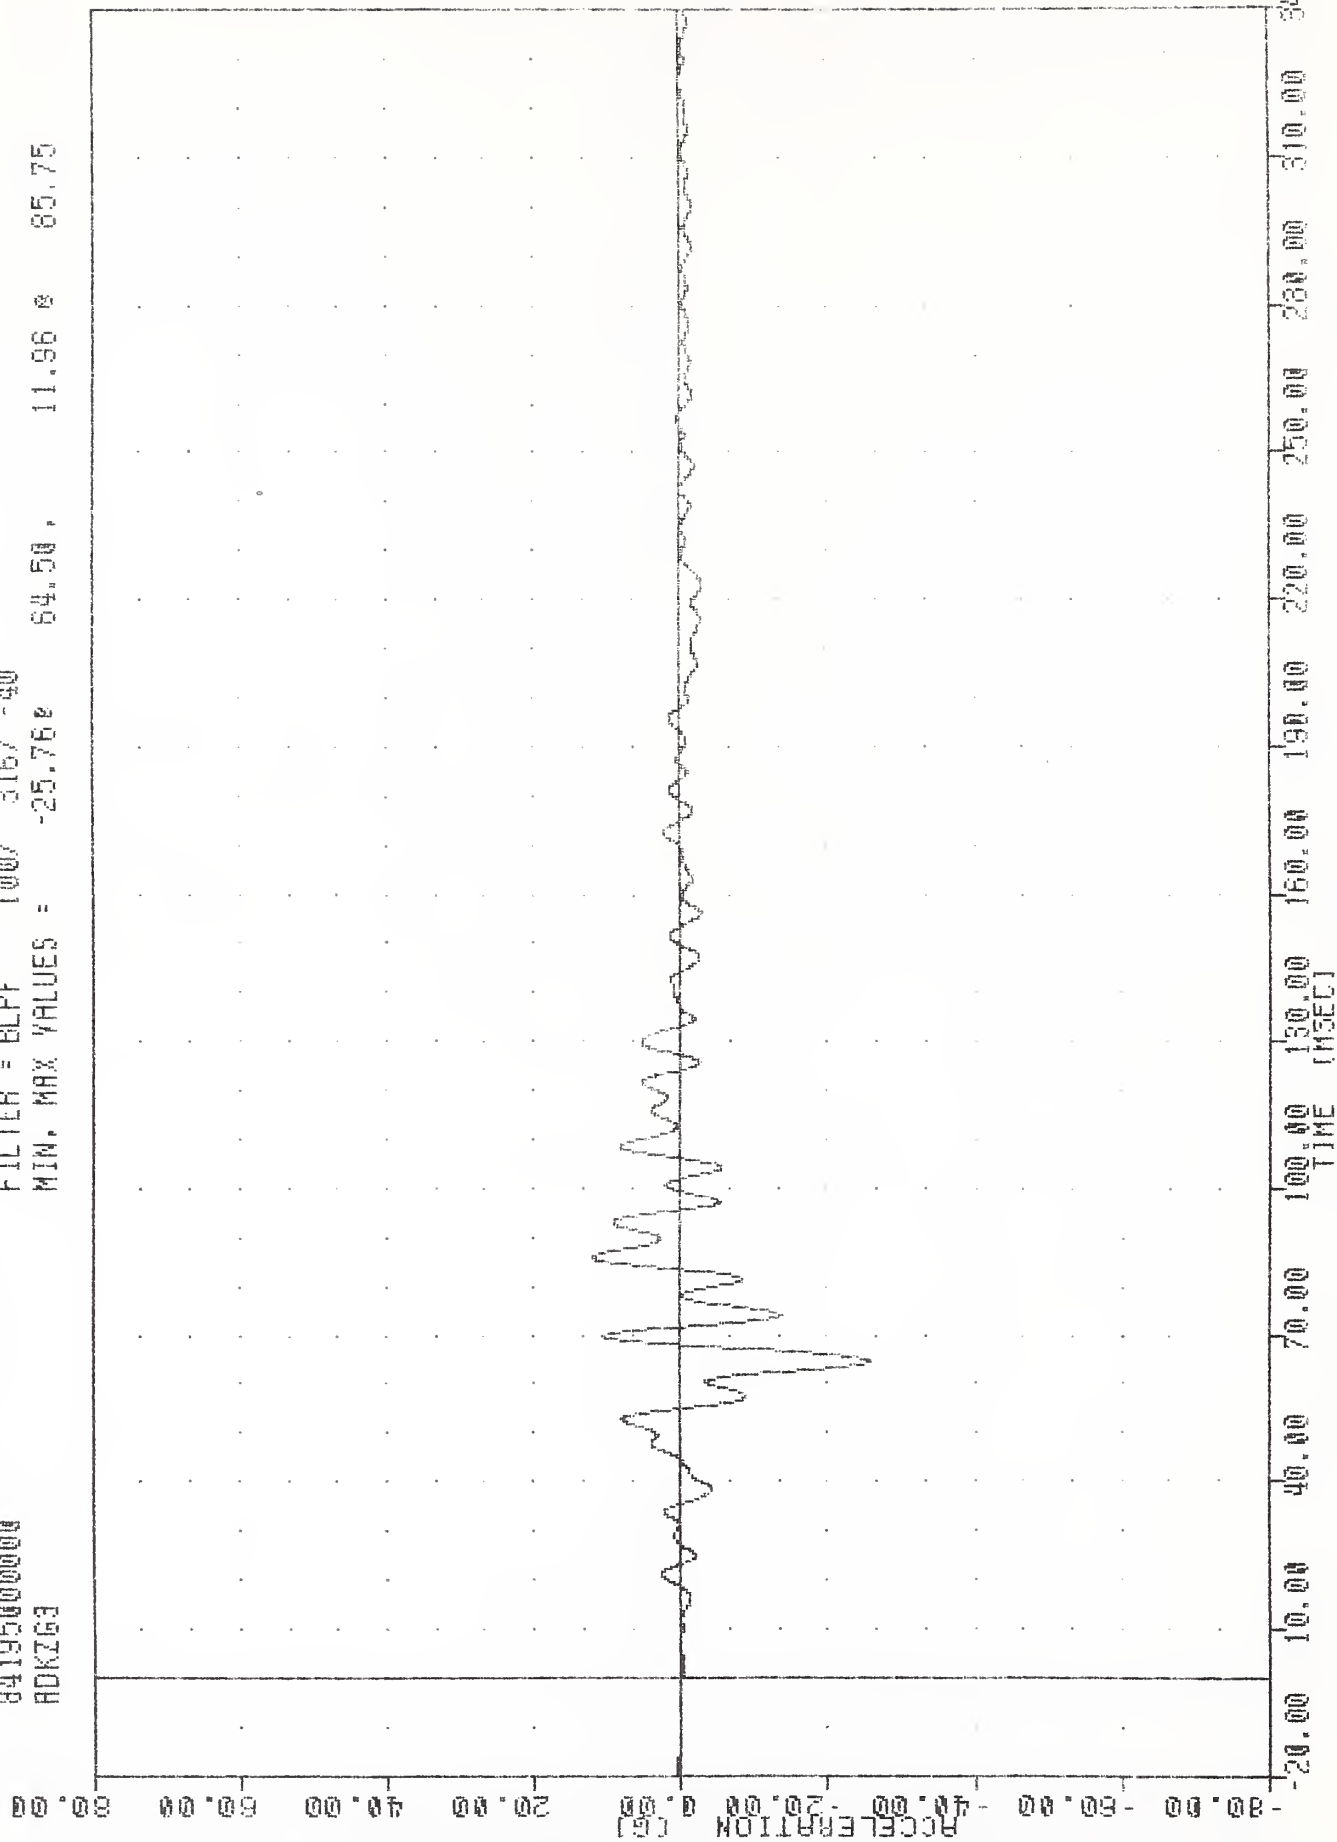
MOVING DEFORMABLE BARRIER INTO VOLKSWAGEN RABBIT
VEHICLE REAR DECK ACCELERATION Z AXIS
